## SALMON PROTECTION AND WATERSHED NETWORK

### Larsen Creek Salmonid Passage Baffles Repair Project

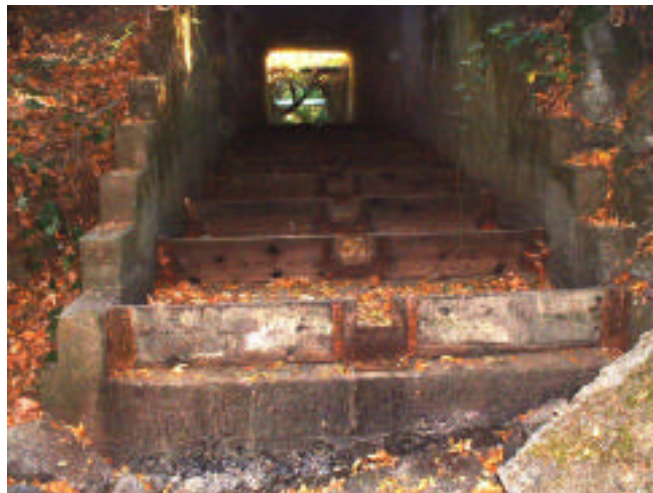
**Problems at the Site:** Encroachment of rip-rap from the right bank has entered the stream channel and is causing the degradation of a jump pool at the base of the culvert. This encroachment has also caused significant erosion on the left bank due to: a) the culvert under SFD; b) armoring of the right bank and c) narrowing of stream channel between the rip rap and a live alder tree in the middle of the channel. Furthermore, the baffles are not water tight and therefore when water levels drop in the spring, flow leaks under the baffles causing hundreds of juvenile salmonids to become trapped. This problem has prompted SPAWN crews to rescue and relocate 200-300 juvenile salmonids from the baffles since 1999.

These wooden baffles leak and trap hundreds of juvenile salmonids each spring.

**Recommended Repair:** We recommend modification of this site to prevent downstream migrants from becoming trapped behind baffles and provide upstream migrants with easy passage by repairing stream channel constriction. Ideally this would entail the complete removal of the culvert and replacement with a wider channel and natural creek bed design. In the short term however, we recommend a less costly modification to provide safe migration passage, particularly for juveniles, by repairing the baffles and a jump pool at the base. Such a short term repair may prevent hundreds of juveniles from dying each spring until the larger culvert replacement and erosion problems can be addressed.

- 1) Seal the weirs and creating a 'V' notch in the baffle for flow\*
- 2) Cut a small opening in the bottom of weirs
- 3) Remove the weirs in summer and replacing before the fall rains

### **Sealing of the Weirs and creating a 'V' notch in the baffle for flow:**

- Implementation:**
- 1) Place net across creek on upstream end and relocate salmonids from the weirs.
  - 2) Clean dirt and gravel from surface around area where epoxy will be applied.
  - 3) Apply epoxy - (Within 30 minutes the substance sets. It will harden within 24 hours.)
  - 4) Remove net across creek on upstream end.
- Monitoring:**
- 5) Monitor weirs to determine if maintaining water tight integrity and survey for salmonids throughout the season and make additional repairs if necessary
  - 6) Survey baffles when creek flow ceases to determine if salmonids remain trapped
